# Manhole Inspection Summary

Manhole # S05UU1005MH

Insp Date: **9/26/06 9:22 AM**

**Location** Address: **NORTHERN PKWY**

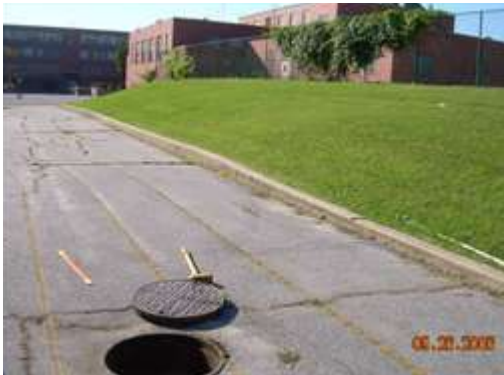
Location View

Comments **The manhole is located on Northern Parkway in a school yard.**

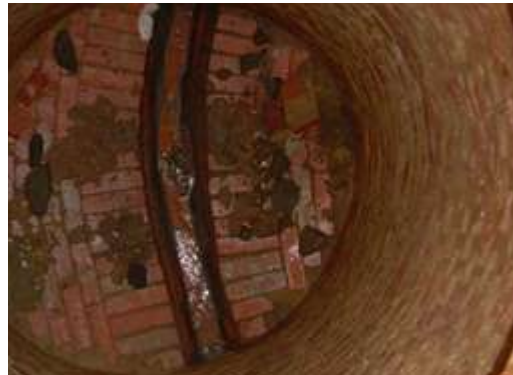
Top View

Frame leaks. Adjustment deterioration.  
Adjustment, Corbel and Barrel infiltration.  
Evidence of surcharge - Bench debris.

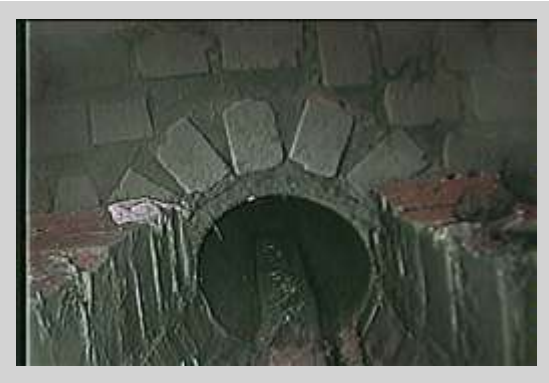
### 8 in. Circular Gravity Sewer Pipe Out @ 12 O'Clock

Deposits: ☐ None ☒ **Mud** ☐ Sludge ☐ Debris ☒ **Grease**

Silt Depth: **0** (in.) Deposits Extent: **Light**

Infiltration: **Evidence** Pipe Seal Cond: **Cracked**

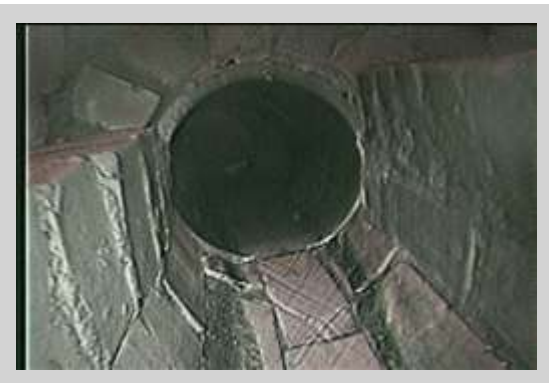
### 8 in. Circular Gravity Sewer Pipe In @ 5 O'Clock

Barrel deterioration and infiltration. Channel deterioration.

Infiltration: **Evidence** Pipe Seal Cond: **Unknown**
